Our Ref: SS279

5 October 2018

REPORT ON ATTIC BRICKWORK REPAIRS TOWN HALL, FELIXSTOWE

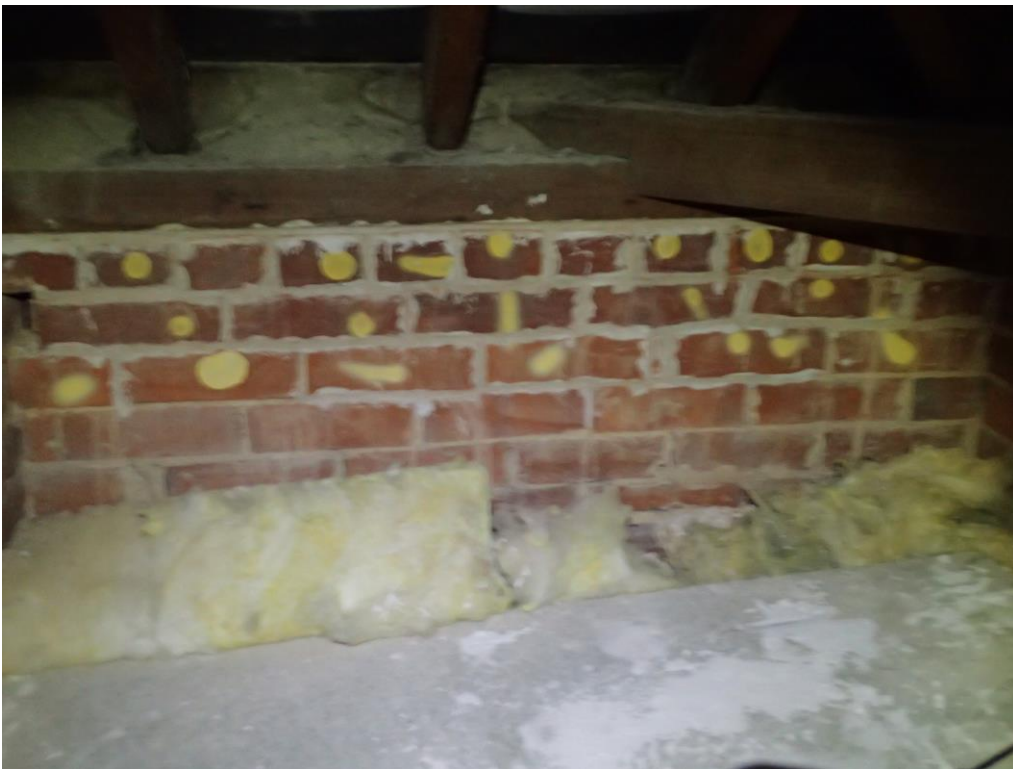
RIGHT HAND SECTION FRONT ELEVATION

- 3.1.2 The chimney to the left-hand side has been satisfactorily repaired.
- 3.1.3 The right-hand side chimney has had the two levels of Helifix bars installed within the horizontal mortar beds. Brickwork had been replaced where damage and defective mortar beds have been repointed or replaced.
- 3.1.4 In a similar way to the above the three brick courses below the wallplate to the front and front part of the right-hand elevation had been replaced where the brickwork was damaged and repointed where the brickwork was still sound.

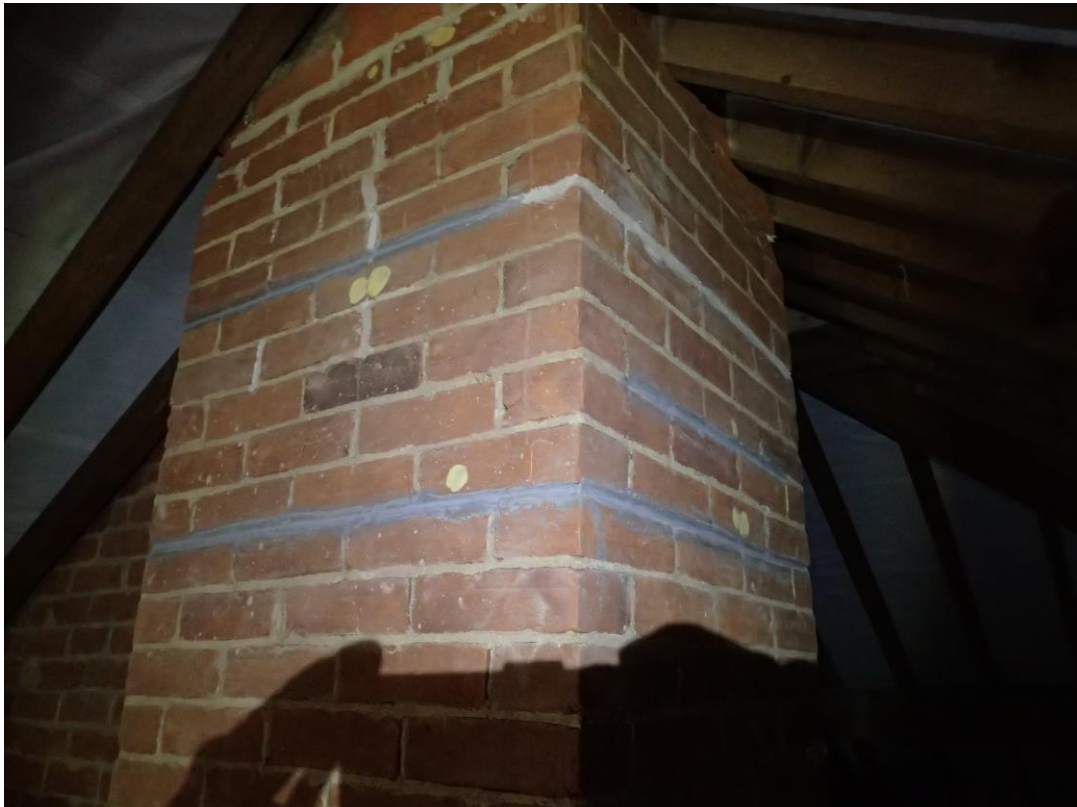
There are vertical chimney cracks on the top section of this chimney which causes it to require two bands of Helifix bars within the bed joints at high level, and a total of 10 courses of brickwork and surrounding mortar to be replaced as necessary.

***RIGHT (SW) CHIMNEY, HELI BAR TIES BEHIND
CONTRASTING MORTAR***

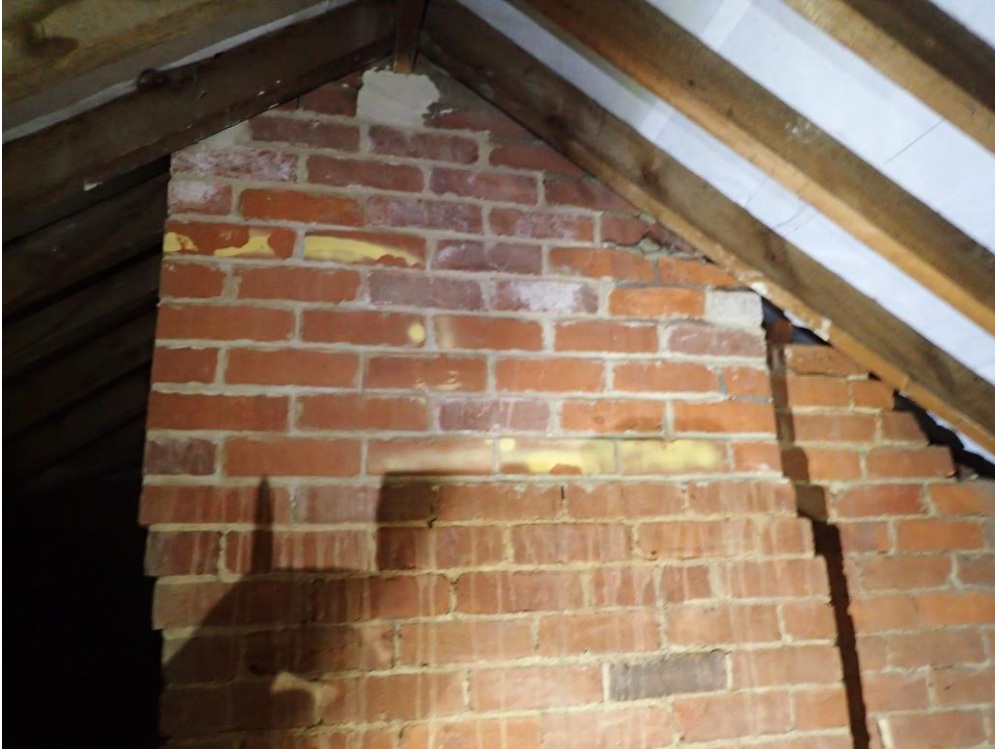
LEFT CHIMNEY.

2.3.2 The left-hand chimney had approximately 10 courses where the brickwork was damaged through spalling of the face and the mortar was particularly degraded. This was to be made good with new bricks where the bricks had a damaged face and generally 10 courses were to be repointed or rebuilt in.

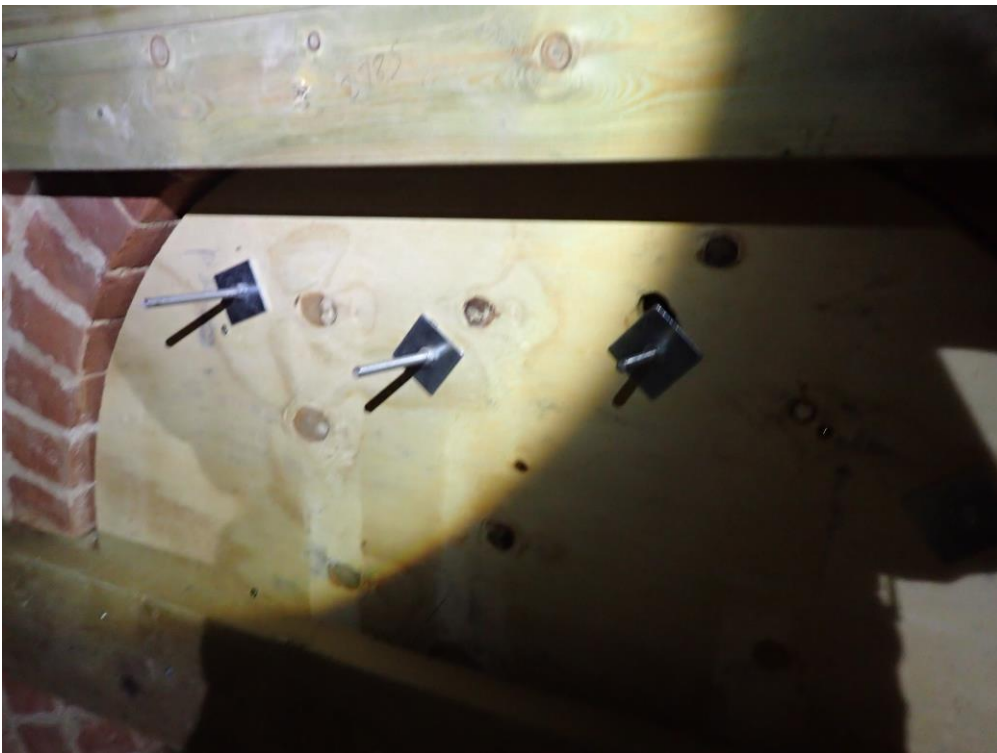
3.1.1 At the time of my visit Item 1, the curved brickwork and the brickwork either side of it down to the RSJ had largely been done utilising some additional timber diaphragm consisting of two 22m plywood sheets cut to a circle, and therefore, to provide support to the arching brickwork. This area had at the time of my visit been satisfactorily carried out. There two loose courses of brickwork (can be moved by hand) immediately over the top plate of the RSJ lintel and these

***PLY DIAPHRAGM TIED TO OUTER FEATURE.
ADDITIONAL TIMBER ROOF SUPPORTS WILL BE LEFT IN PLACE***

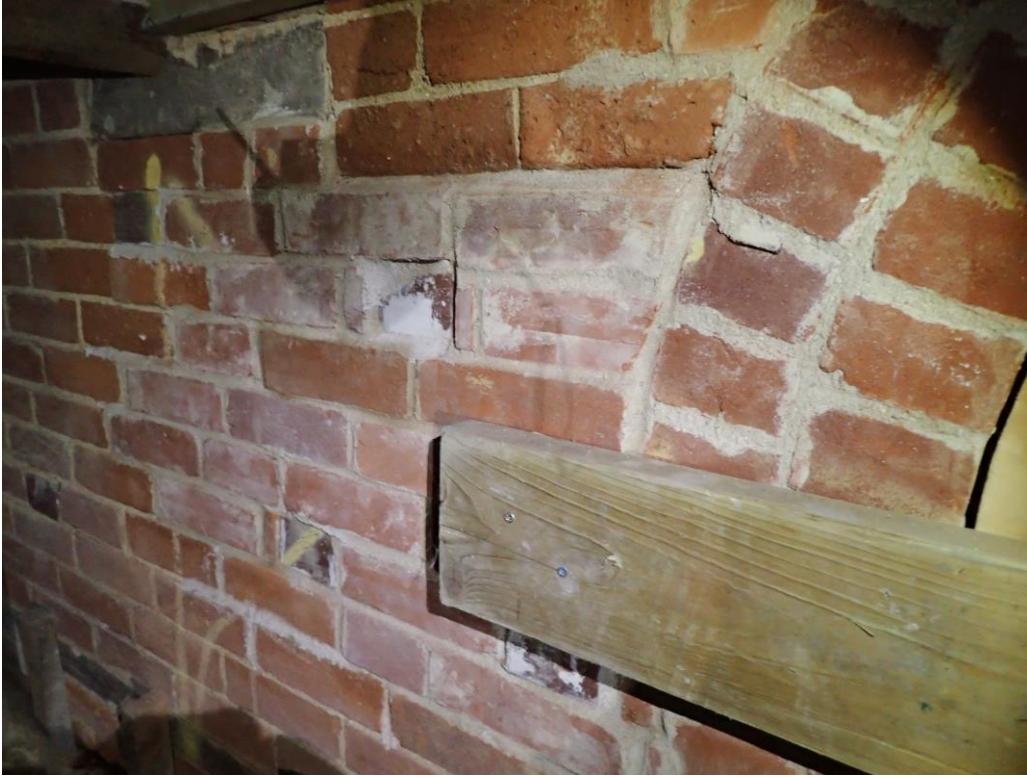
2.3.1 In the area of the front facing gable which is towards the north east corner of the building, i.e. left front, a requirement was made to rebuild the circular feature of the brickwork and some brickwork on either side and down to the RSJ lintel.

BRICKWORK MADE GOOD EITHERSIDE OF ARCH

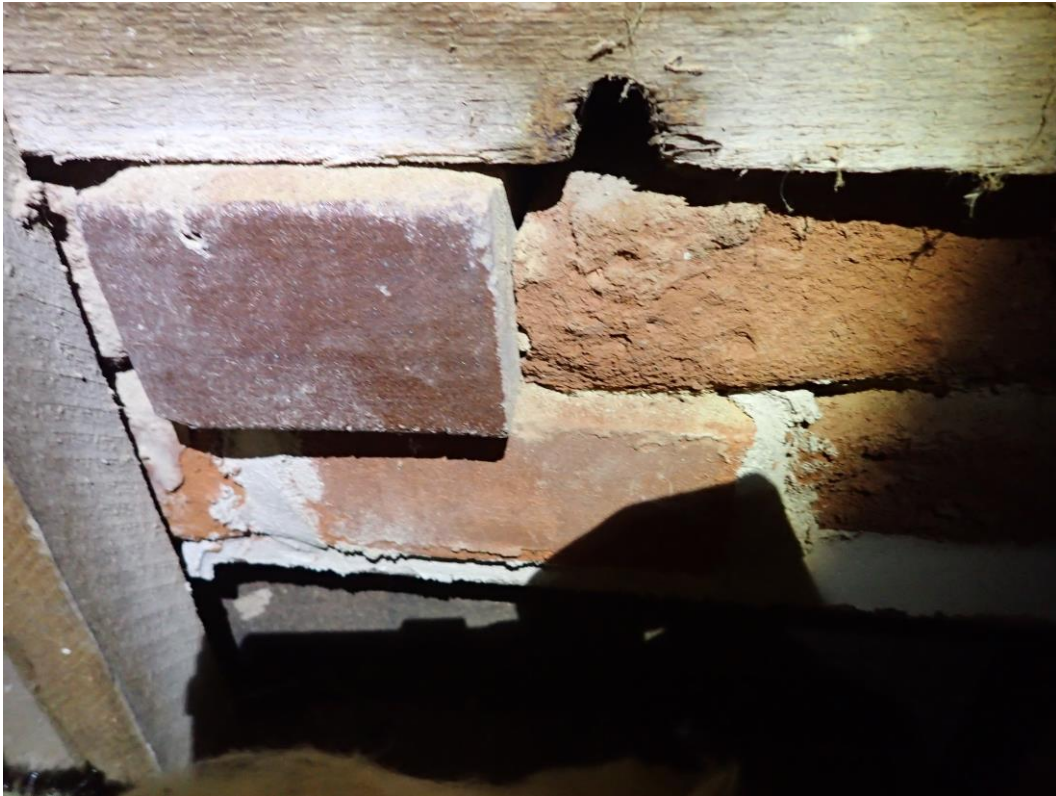
require repacking with lime mortar.

***BRICKWORK OVER RSJ LINTEL HAS BEEN MADE GOOD WITH
FRESH LIME MORTAR POINTING.***

- 4.1 I recommended for the purposes of this completion report that some repointing needs to be carried out to the two courses immediately over the RSJ lintel. In all other respects, the work has been carried out satisfactorily in accordance with my specification of the 9 July 2018.
- 4.2 With effect from 10th October the work has been properly carried out in Area 1, i.e. the front gable, the whole attic area should remain free from the need to carry out further maintenance for a period of at least 5 years but should be inspected thereafter at 5 year intervals.
