BP477A
3rd January 2024

ROOF REPORT

TOWN HALL FELIXSTOWE

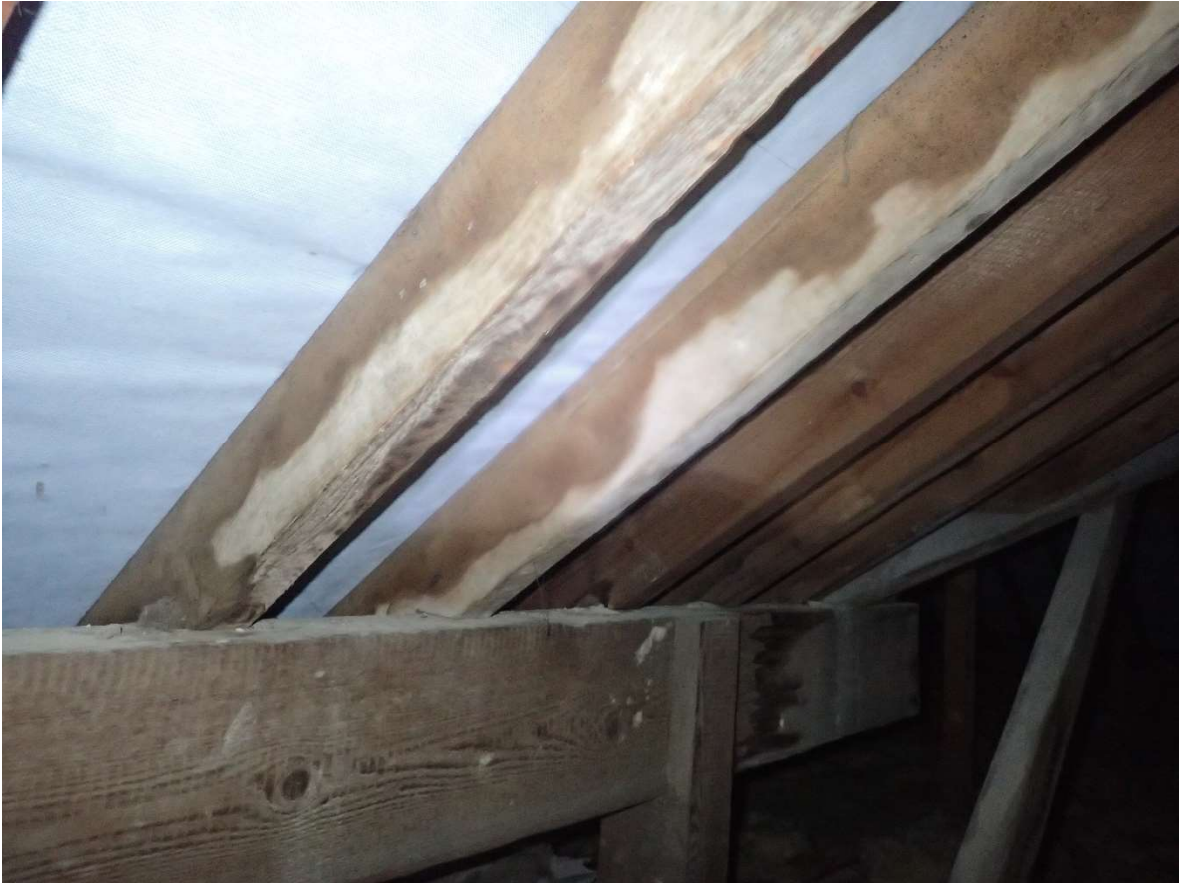
- 3.4 Ridge junction, also over the main council chamber, but nearer the door. Moisture content highest just above channel, on either side of side-to-side ridge, up to 40% moisture content.
- 3.5 Lower part of channel, over landing, near top of stairs. Visible water tracking in dust, maximum 35% moisture content.
- 3.6 To south-west of north-east chimney, to the rear of ridge, three rafters show 35% moisture content over about a 2m length. The nearest rafter to the chimney is not as damp.
- 3.7 Also, to south-west of north-east chimney, but front side of ridge: about 35% moisture content to 3 no rafters matching 3.6 above.

DAMP RAFTERS AS DESCRIBED IN 3.5

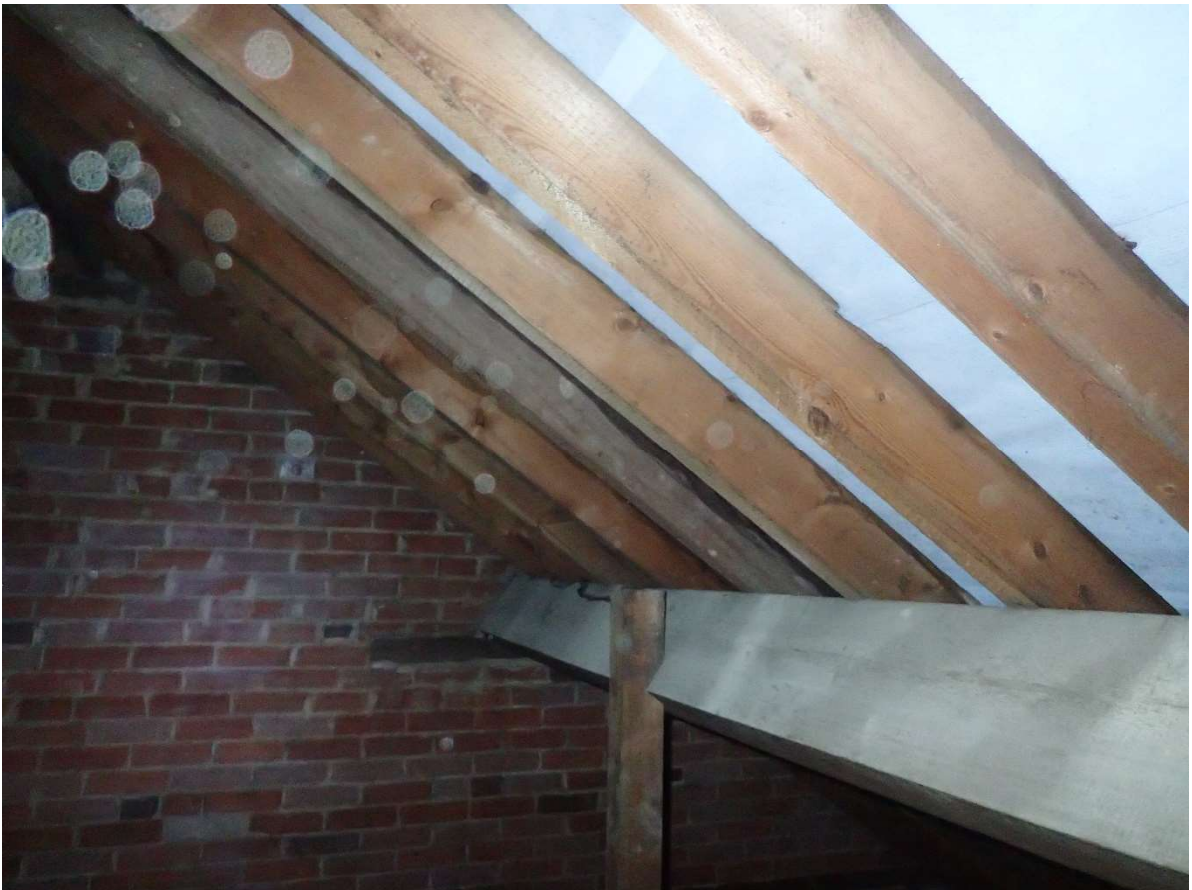
- 3.2 There are 5 distinct areas where damp is clearly visible on the sides of rafters:
- 3.3 Mid North-East, an area over the main Council chamber. Maximum moisture measured at 50% at top of several rafters.

N.E. AREA, LOCAL HIGH MOISTURE CONTENTS.

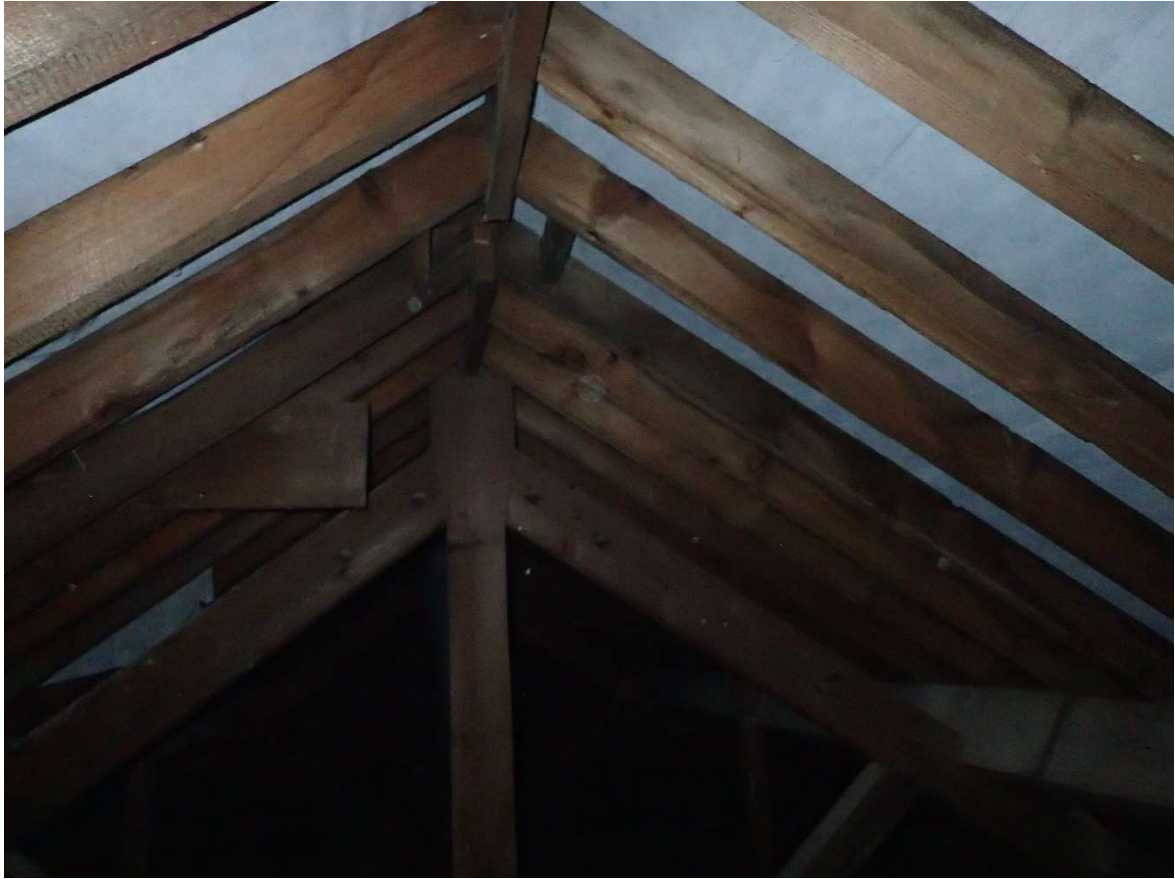
- 4.6 Currently there is the first sign of wet rot forming to the NE area as described in 3.3 above, this has not yet had a significant impact on the rafter structure. However, replacing the felt should be seen as relatively urgent work, to be carried out in the next 2 years, ideally sooner.

RAFTERS OVER COUNCIL CHAMBER AREA DESCRIBED IN 3.3

- 4.4 Based on its performance I have to conclude that it is not a recognised breathable felt, and it is not suitable for this use.
- 4.5 I therefore recommend that it be replaced entirely by a recognised breathable felt.

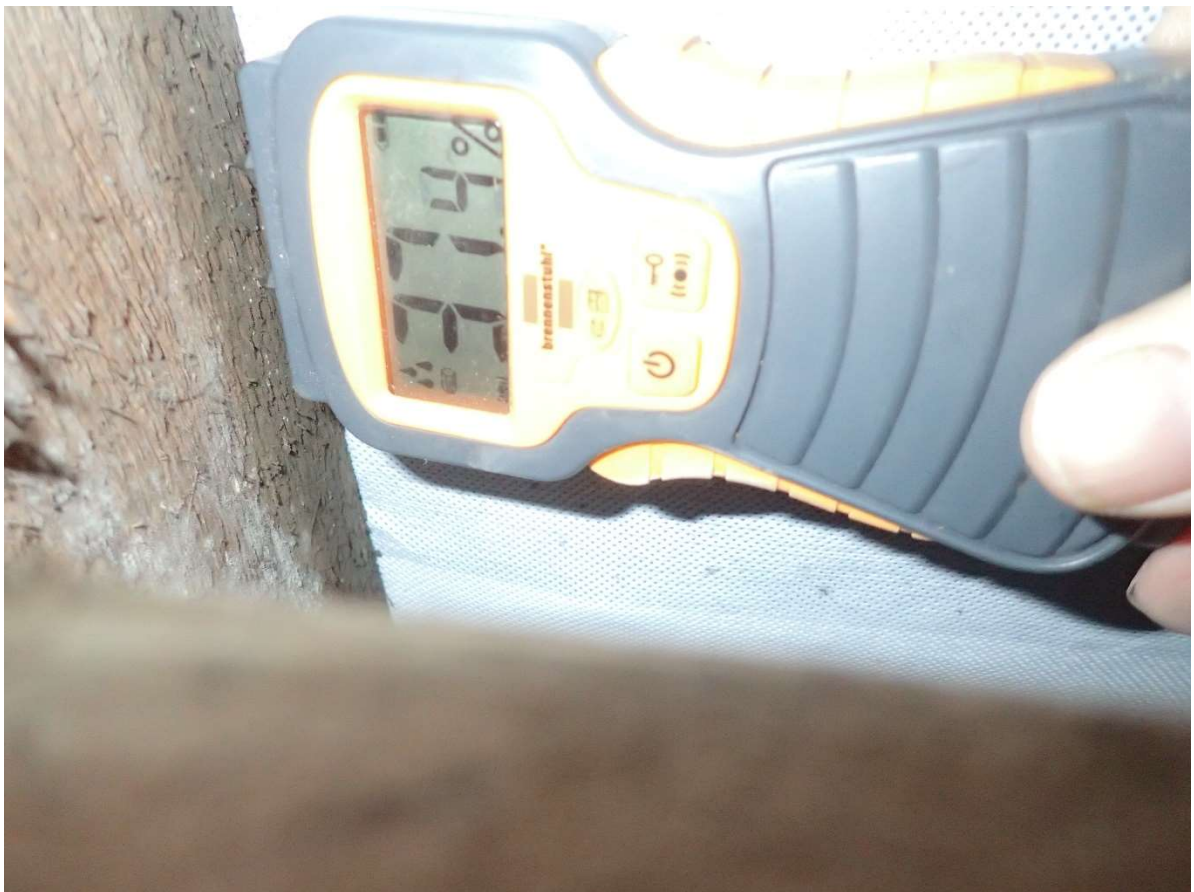
TYPICAL READING IN UPPER HALF OF RAFTER.
