**Our Ref: SS279**

## **REPORT ON ATTIC BRICKWORK REPAIRS TOWN HALL, FELIXSTOWE**

**REPORT ON ATTIC BRICKWORK REPAIRS  
TOWN HALL FELIXSTOWE**

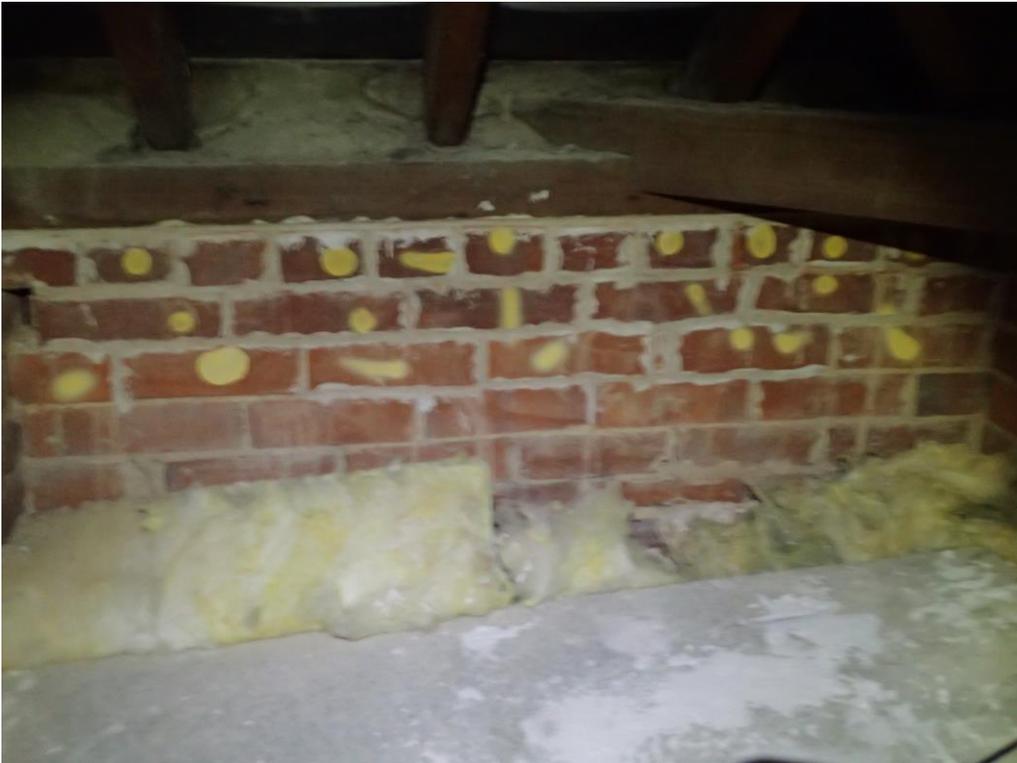
***RIGHT HAND SECTION FRONT ELEVATION***

- 3.1.2 The chimney to the left-hand side has been satisfactorily repaired.
- 3.1.3 The right-hand side chimney has had the two levels of Helifix bars installed within the horizontal mortar beds. Brickwork had been replaced where damage and defective mortar beds have been repointed or replaced.
- 3.1.4 In a similar way to the above the three brick courses below the wallplate to the front and front part of the right-hand elevation had been replaced where the brickwork was damaged and repointed where the brickwork was still sound.

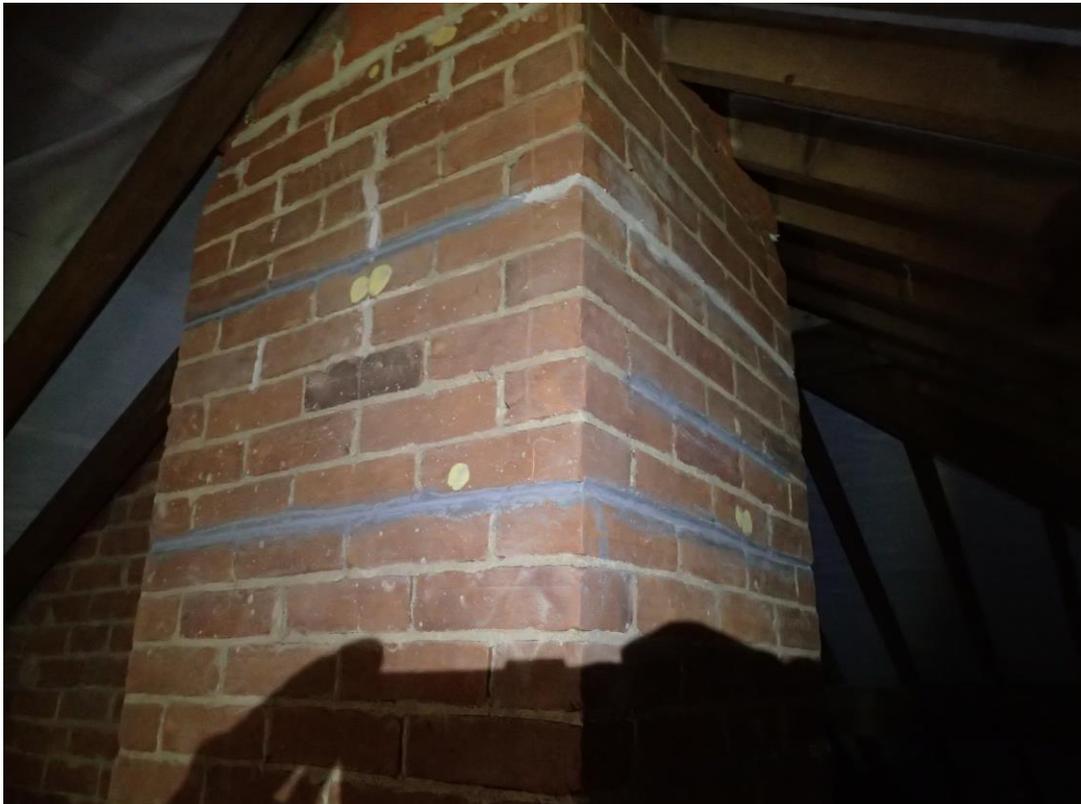
There are vertical chimney cracks on the top section of this chimney which causes it to require two bands of Helifix bars within the bed joints at high level, and a total of 10 courses of brickwork and surrounding mortar to be replaced as necessary.

***RIGHT (SW) CHIMNEY, HELI BAR TIES BEHIND  
CONTRASTING MORTAR***

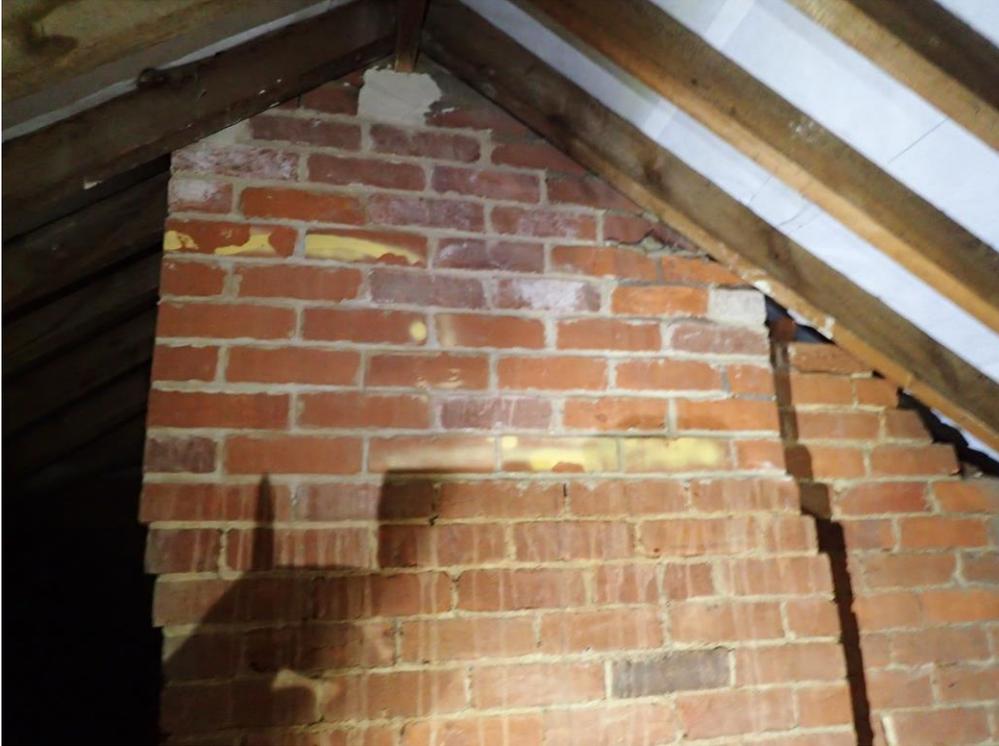
***LEFT CHIMNEY.***

2.3.2 The left-hand chimney had approximately 10 courses where the brickwork was damaged through spalling of the face and the mortar was particularly degraded. This was to be made good with new bricks where the bricks had a damaged face and generally 10 courses were to be repointed or rebuilt in.

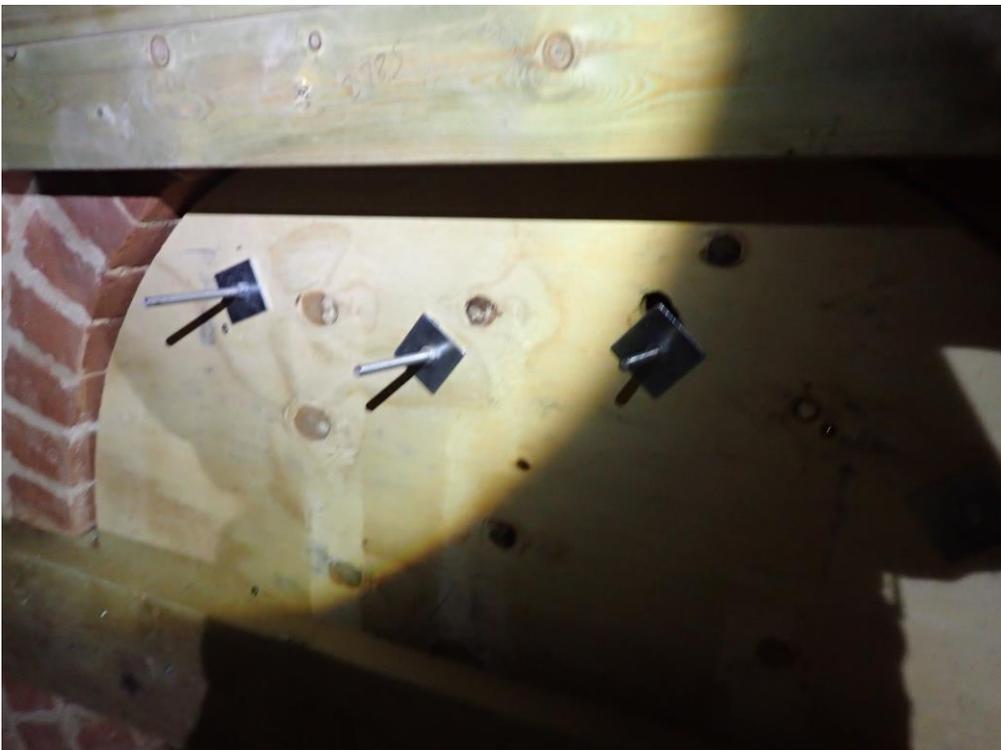
3.1.1 At the time of my visit Item 1, the curved brickwork and the brickwork either side of it down to the RSJ had largely been done utilising some additional timber diaphragm consisting of two 22m plywood sheets cut to a circle, and therefore, to provide support to the arching brickwork. This area had at the time of my visit been satisfactorily carried out. There two loose courses of brickwork (can be moved by hand) immediately over the top plate of the RSJ lintel and these

***PLY DIAPHRAGM TIED TO OUTER FEATURE.  
ADDITIONAL TIMBER ROOF SUPPORTS WILL BE LEFT IN PLACE***

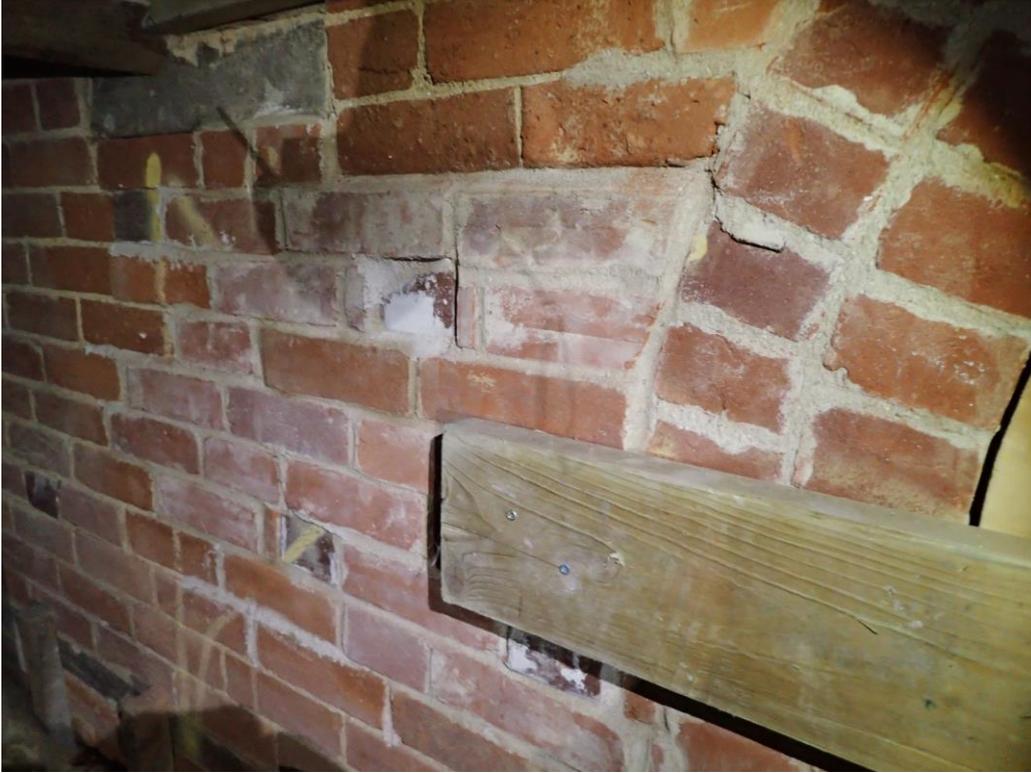
2.3.1 In the area of the front facing gable which is towards the north east corner of the building, i.e. left front, a requirement was made to rebuild the circular feature of the brickwork and some brickwork on either side and down to the RSJ lintel.

***BRICKWORK MADE GOOD EITHERSIDE OF ARCH***

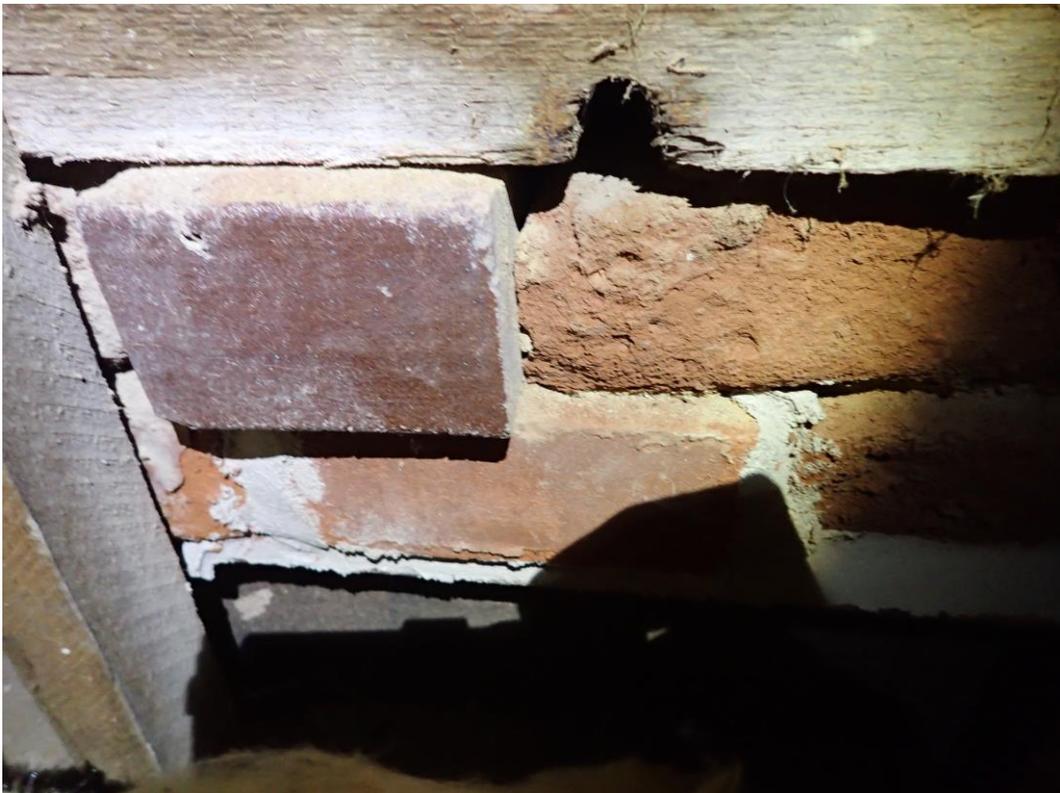
require repacking with lime mortar.

***BRICKWORK OVER RSJ LINTEL HAS BEEN MADE GOOD WITH  
FRESH LIME MORTAR POINTING.***

- 4.1 I recommended for the purposes of this completion report that some repointing needs to be carried out to the two courses immediately over the RSJ lintel. In all other respects, the work has been carried out satisfactorily in accordance with my specification of the 9 July 2018.
- 4.2 With effect from 10<sup>th</sup> October the work has been properly carried out in Area 1, i.e. the front gable, the whole attic area should remain free from the need to carry out further maintenance for a period of at least 5 years but should be inspected thereafter at 5 year intervals.
