**FELIXSTOWE WAR MEMORIAL  
REPORT ON CONDITION**

**Felixstowe Town Council  
Town Hall  
Felixstowe  
Suffolk  
IP11 2AG**

**4<sup>th</sup> October 2018  
PEO/cm/5808/1**

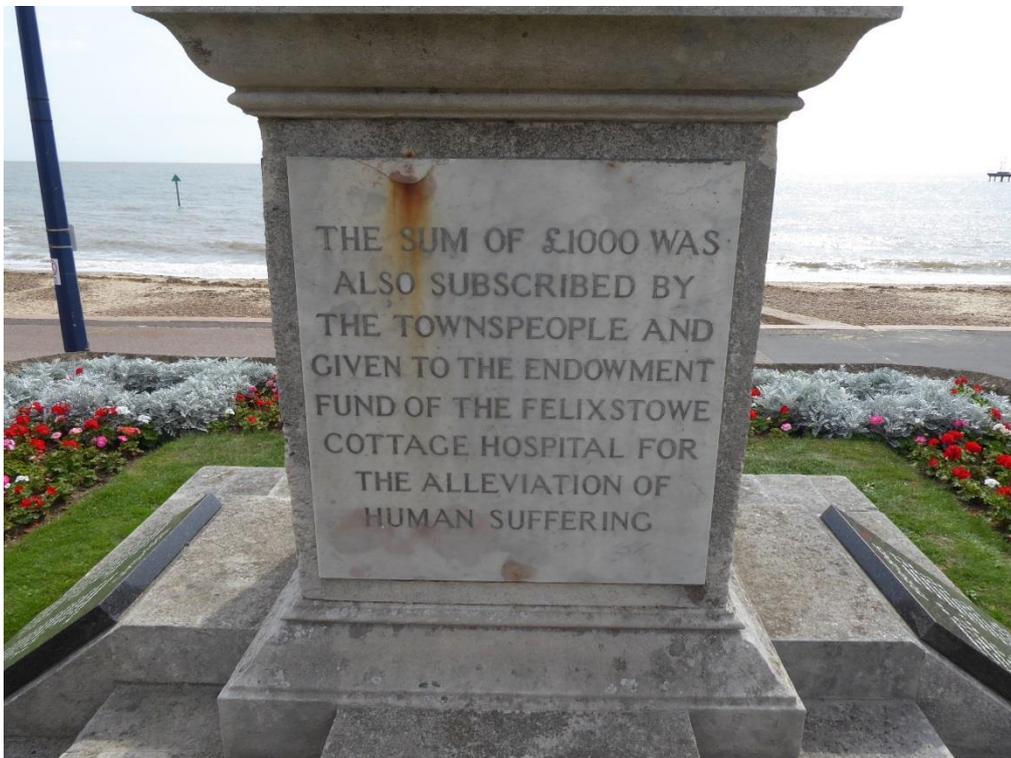
**6. WWI North tablet**

- 4.2 **First World War Memorial tablets:** these are of white marble and appear to be held to the plinth with iron dowels or cramps. There are obvious defects with cracking on the north tablet and staining on the site of the cramps; staining on the east tablet; loss of the marble surface in one position on the south and staining in another and staining on the west tablet. The west tablet also has a bed in the marble on the south edge; this forms a weakness although it is held captive.

- 4.3 The tablets appear to be soundly held at present but as can be seen on the south and also on the north the iron fixings are gradually rusting, expanding and damaging the tablets and also causing unsightly iron staining. The tablets should be supported by a stone conservator, cleaned and refixed with stainless steel or bronze dowels. This will require drilling out of the fixings and a detailed method statement will need to be evolved with a conservator to ensure the best job possible. B

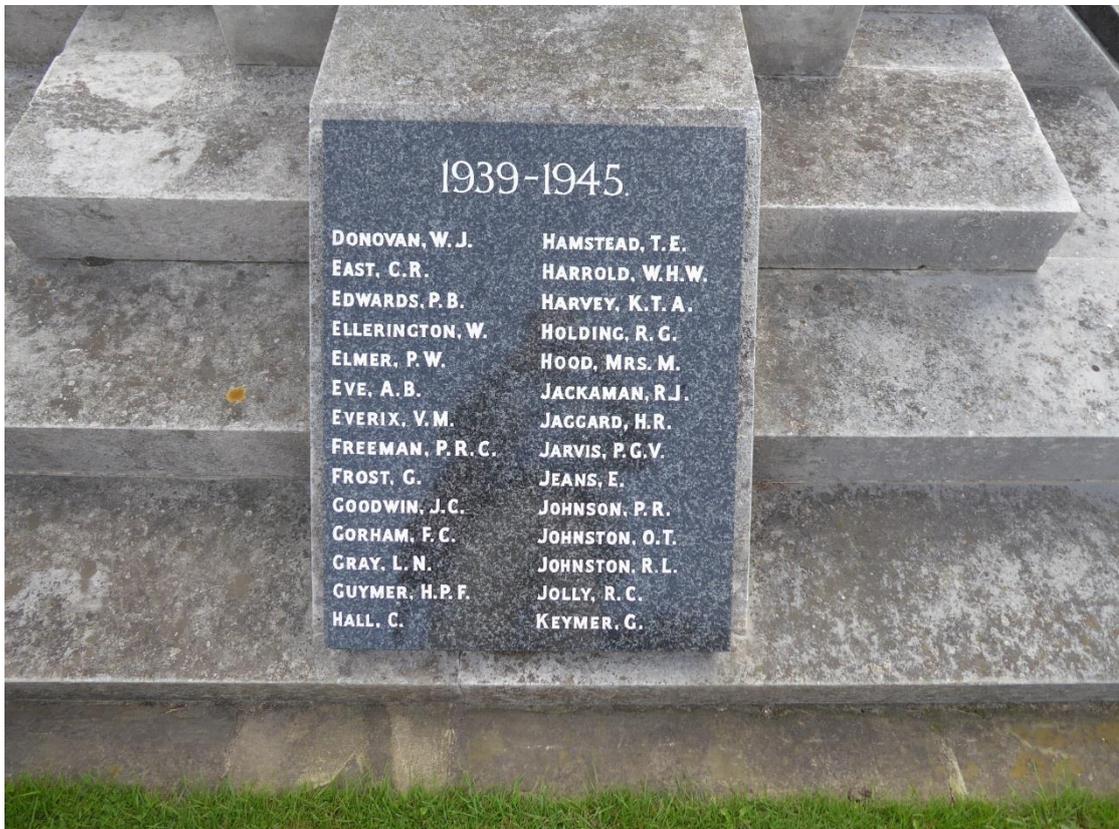
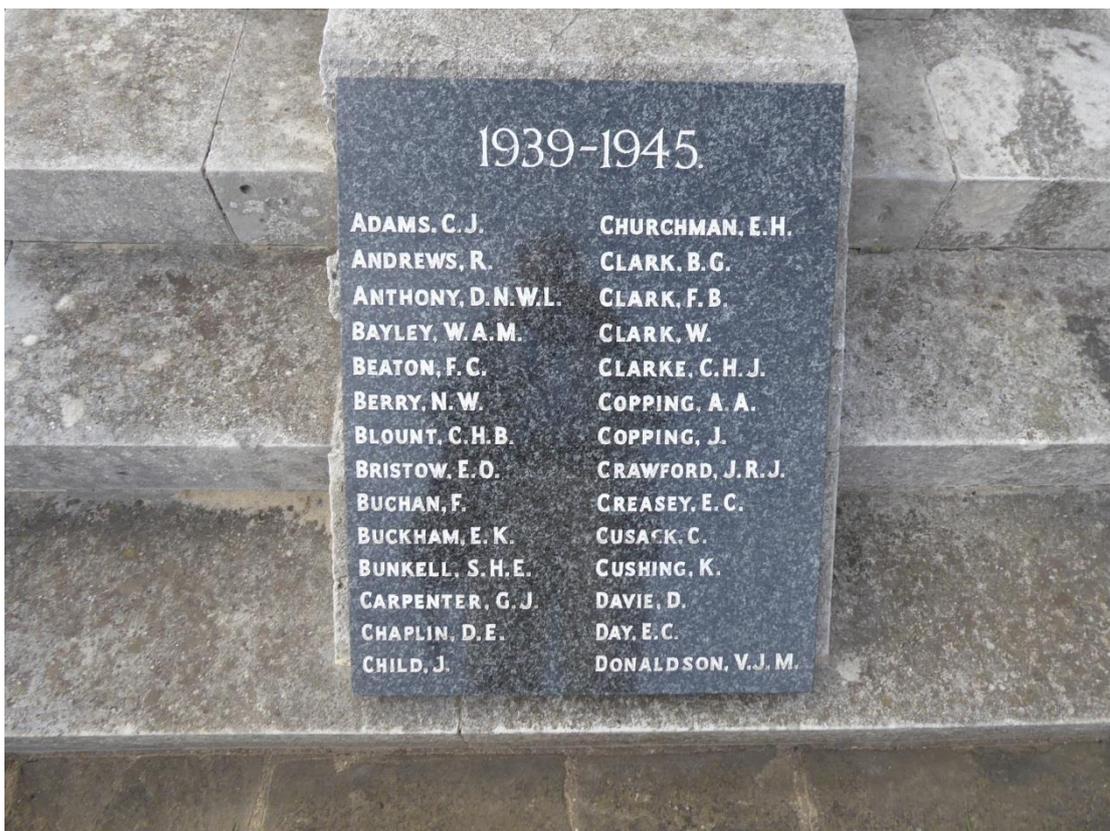
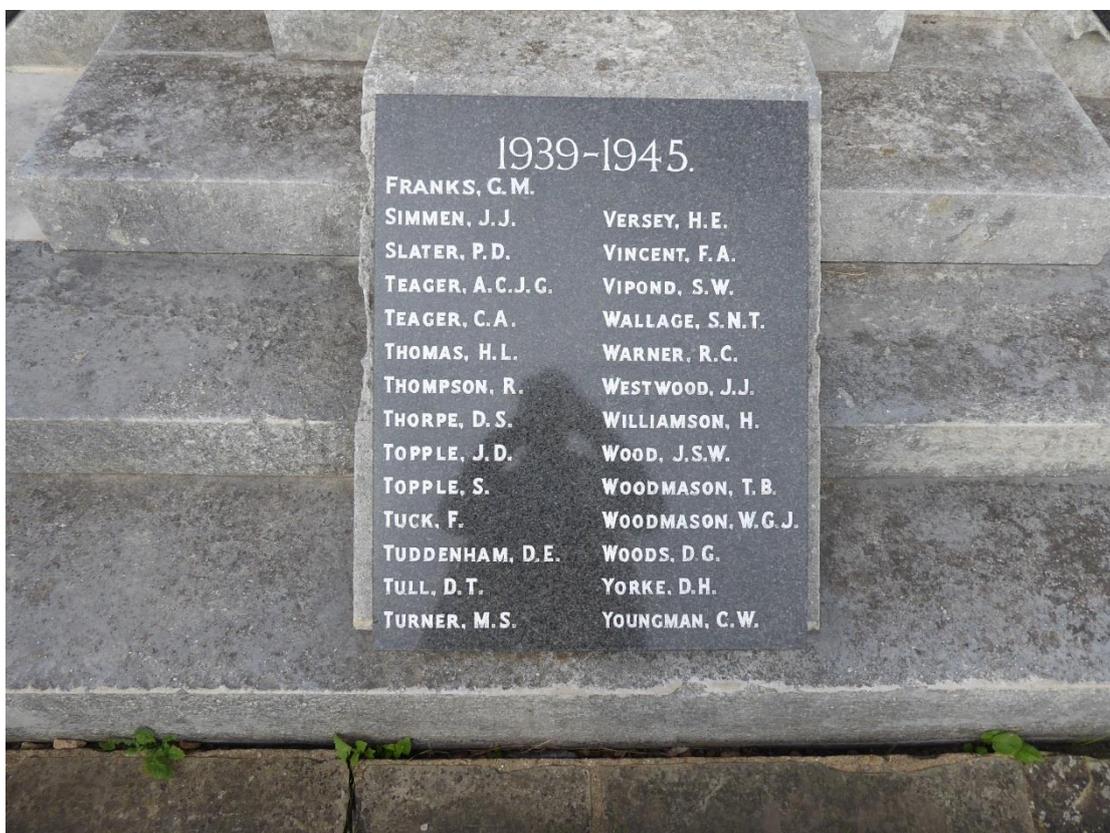
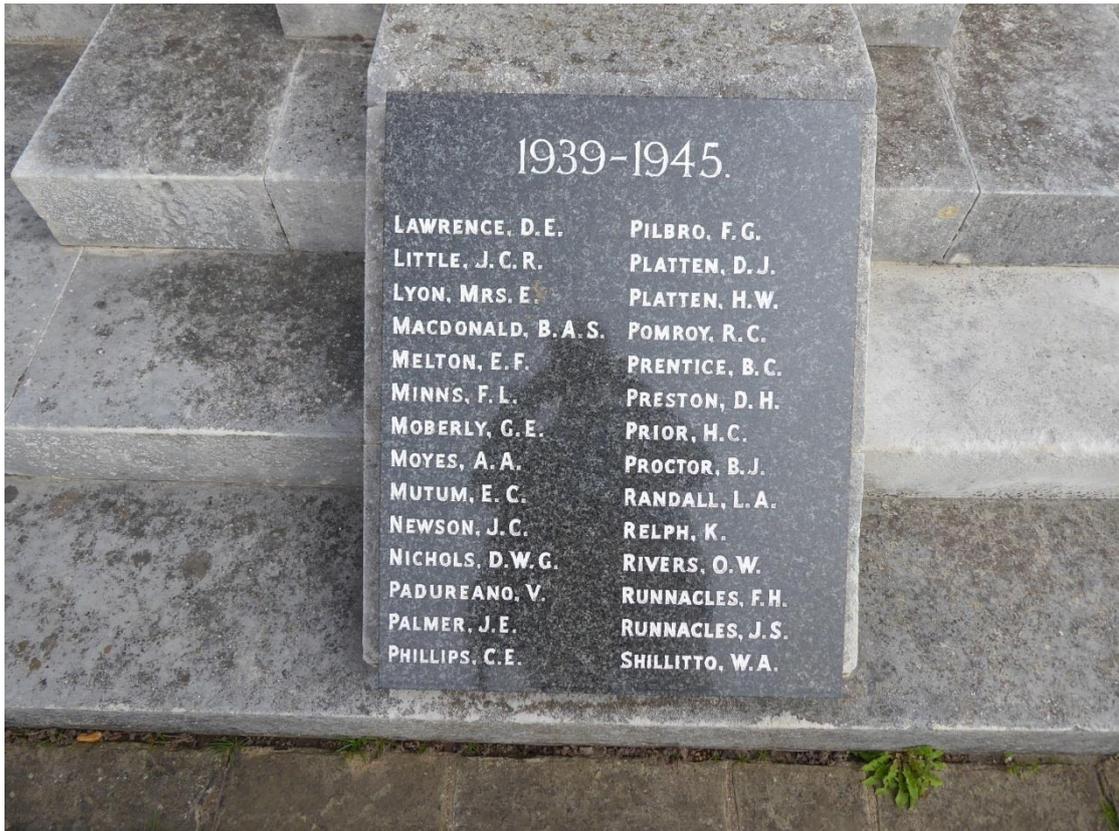
- 4.0 **MEMORIAL TABLETS**
- 4.1 **Second World War tablets:** these are all in satisfactory condition. It is believed that the lettering was repainted approximately 10 years ago. At this stage assume that repainting may be needed in 5 to 10 years' time? E

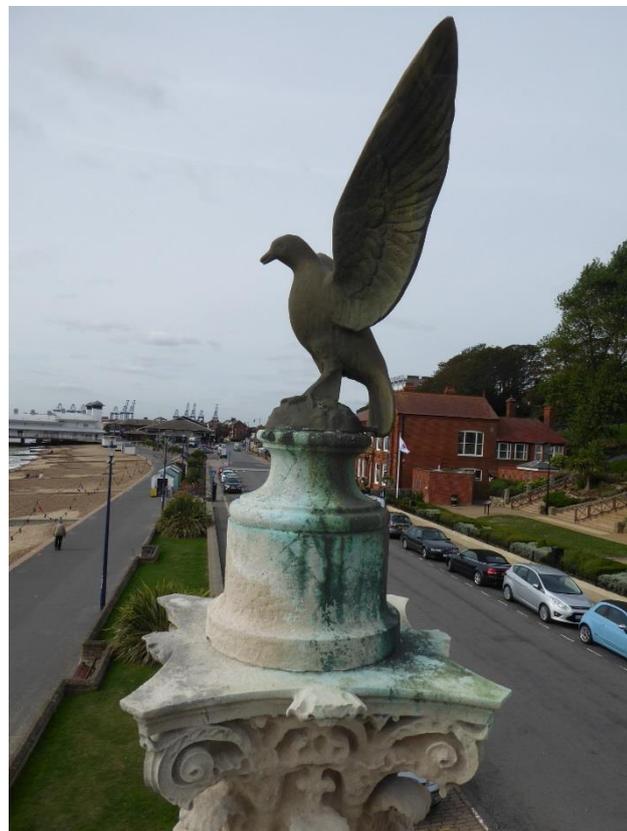
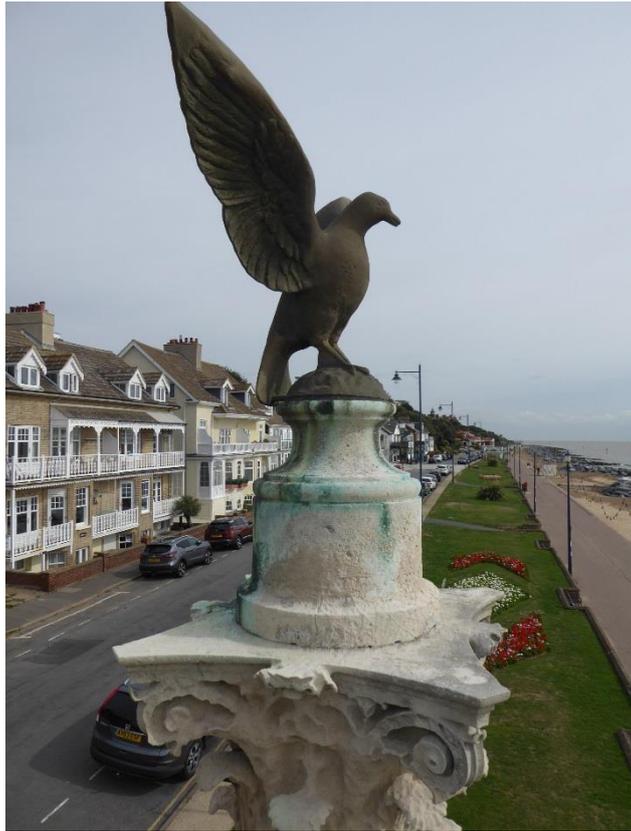
- 3.1 The condition reading from the top downwards is as follows:
- 3.2 **Dove figure:** this is in sound order. It is held to the top of the monument with screws which appear to be sound. The figure is securely held. It is reported that there was an olive branch in the dove's beak.

- 3.3 **The urn:** this is much stained by verdigris from a former bronze or copper dove but the stonework is in reasonable order. There is apparent cracking in places although this appears to be a bed in the stone and does not pose any threat at this stage. It is not clear why there should be verdigris present when the old figure was of lead.

**14. Dove and urn from east**

**15. Dove and urn from west**

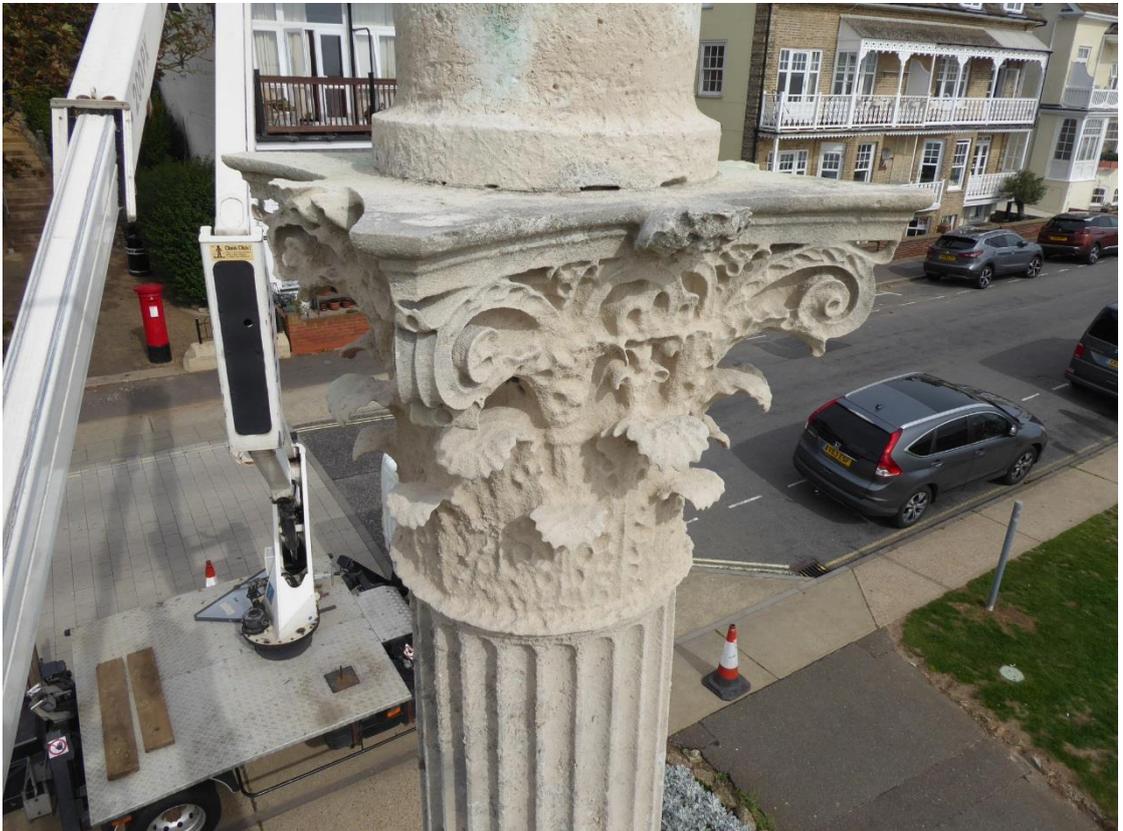
- 3.4 **The capital:** the top surfaces are satisfactory. The stonework in general is structurally sound. There has been much erosion of detail particularly on the seaward faces. The landward face is less eroded and detail remains crisp. The curled leaves of the stonework and the detail of the scrolls at the corners is eroding to a greater or lesser extent but all elements remain securely held. These will continue to erode over time and given the exposure and the height, it may be best to accept that in say, 50 years' time, a complete new stone capital will be needed. By that time leaves will have been lost completely in various positions. In the shorter term however, it would help the survival of the stonework to remove the black soot deposits under the stonework in places. B

**16. Capital from south west**

- 3.5 The joint between the capital and the column shaft is open in places and in need of pointing. The existing mortars should be sampled and analysed since these seem to have been quite successful in surviving. Samples could be taken at low level to inform the eventual mortar mix. B

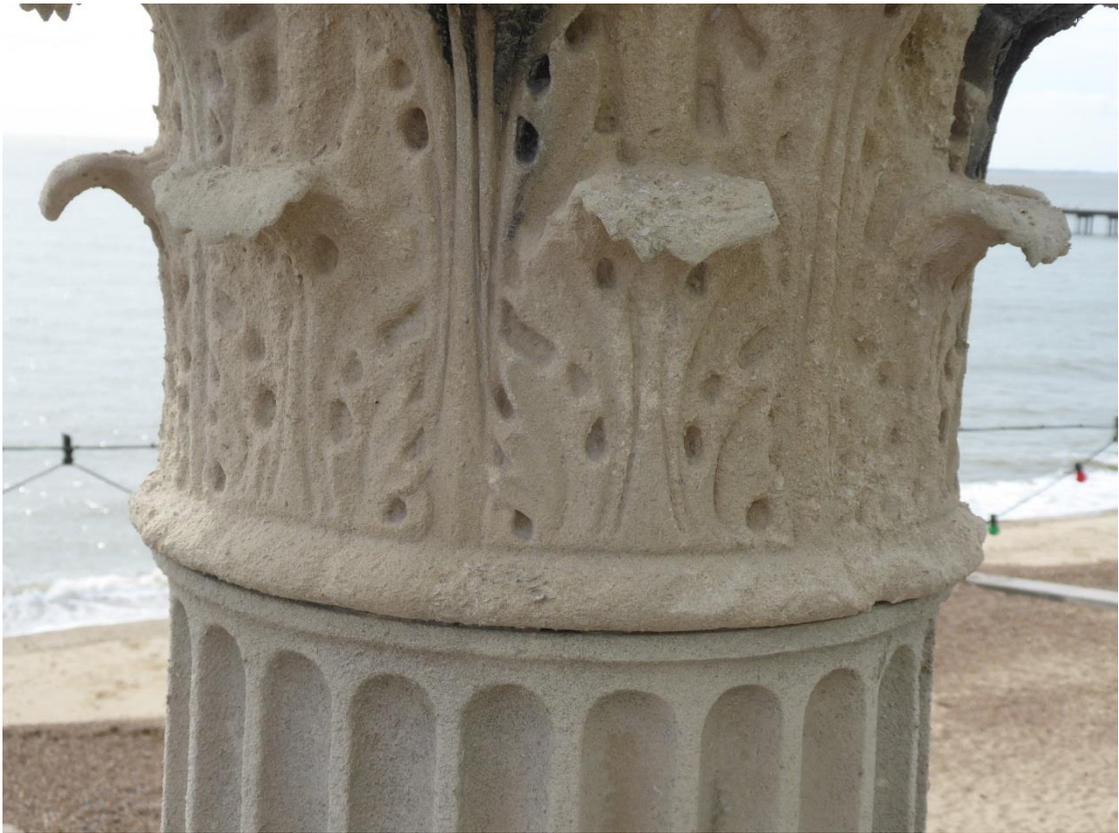
**17. Capital detail, North**

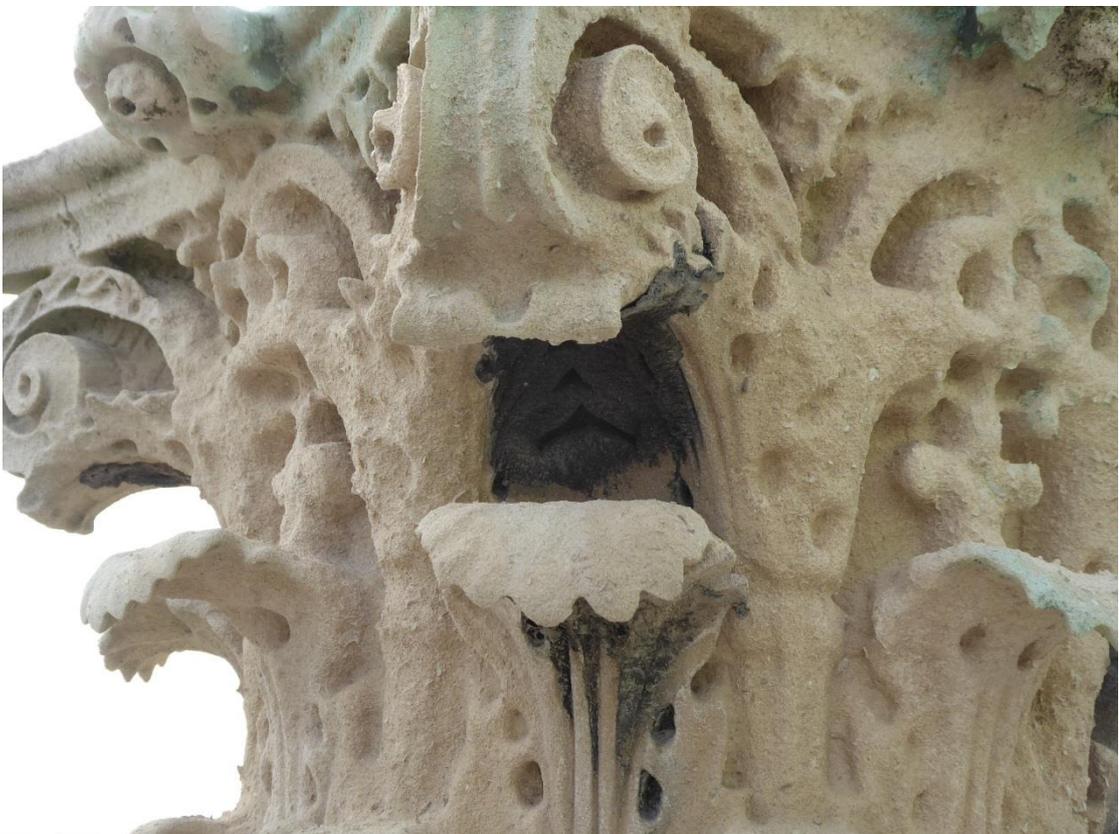
**18. Capital detail: south**

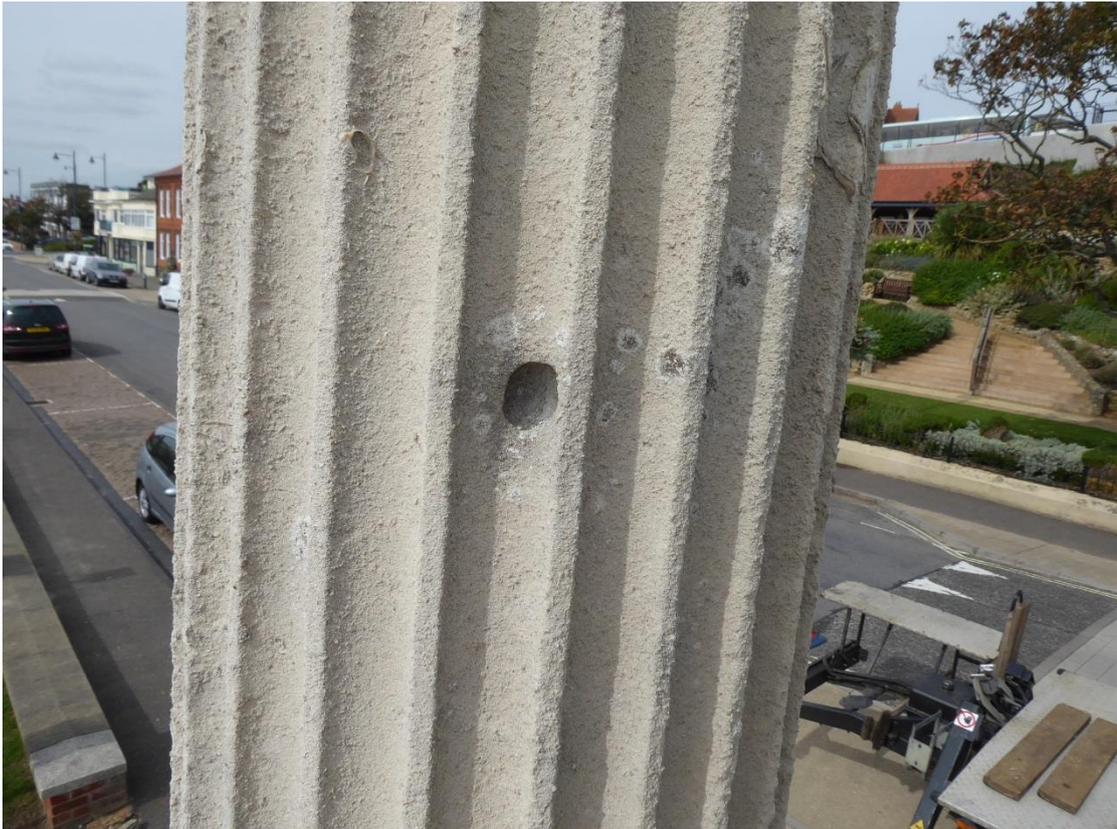
- 3.6 **The column shaft:** the surfaces have eroded particularly on the seaward sides. Given that the column has been in position for 98 years the degree of erosion is remarkably small. There is certainly no structural threat arising from this erosion. Being a natural material comprising the remains of sea creatures laid down millions of years ago, the stone shows shells where it has eroded and in one position a pebble or larger fossil has fallen out leaving a hole. This is self-draining and is not in itself problematic but it is close to the edge of one of the flutes of the column; point it so that the flute's erosion is slowed. The mortar will be sacrificial and will in the course of time erode faster than the stonework. B

19. Shaft: hole

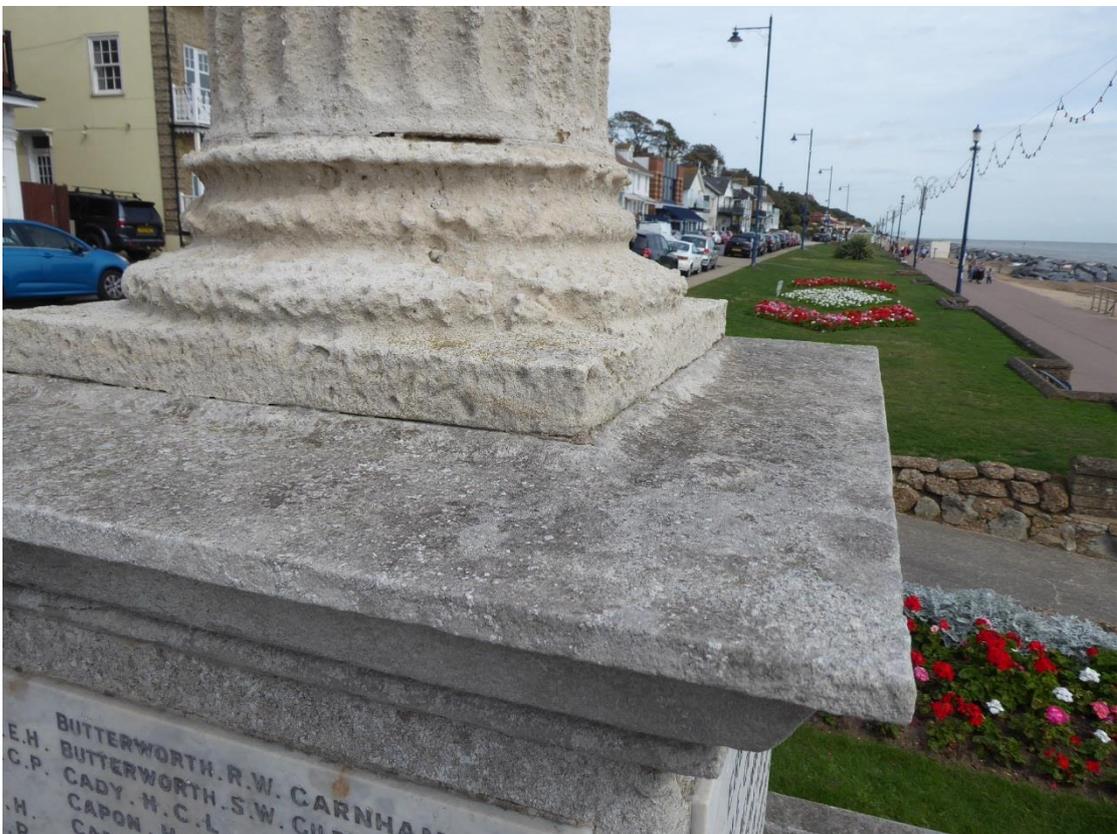
- 3.7 **Column base:** this again is much eroded on the seaward side, particularly the south west side. The worst erosion is on the south west corner. This appears to coincide with a slightly softer bed in the stone. The stone is all structurally stable (indeed, there is a light growth of lichens on the horizontal surfaces suggesting that there is very little erosion ongoing here). No work is suggested but clean out and point up the joints between the base and the shaft on the south east and south west sides. B

20. Column base from south west

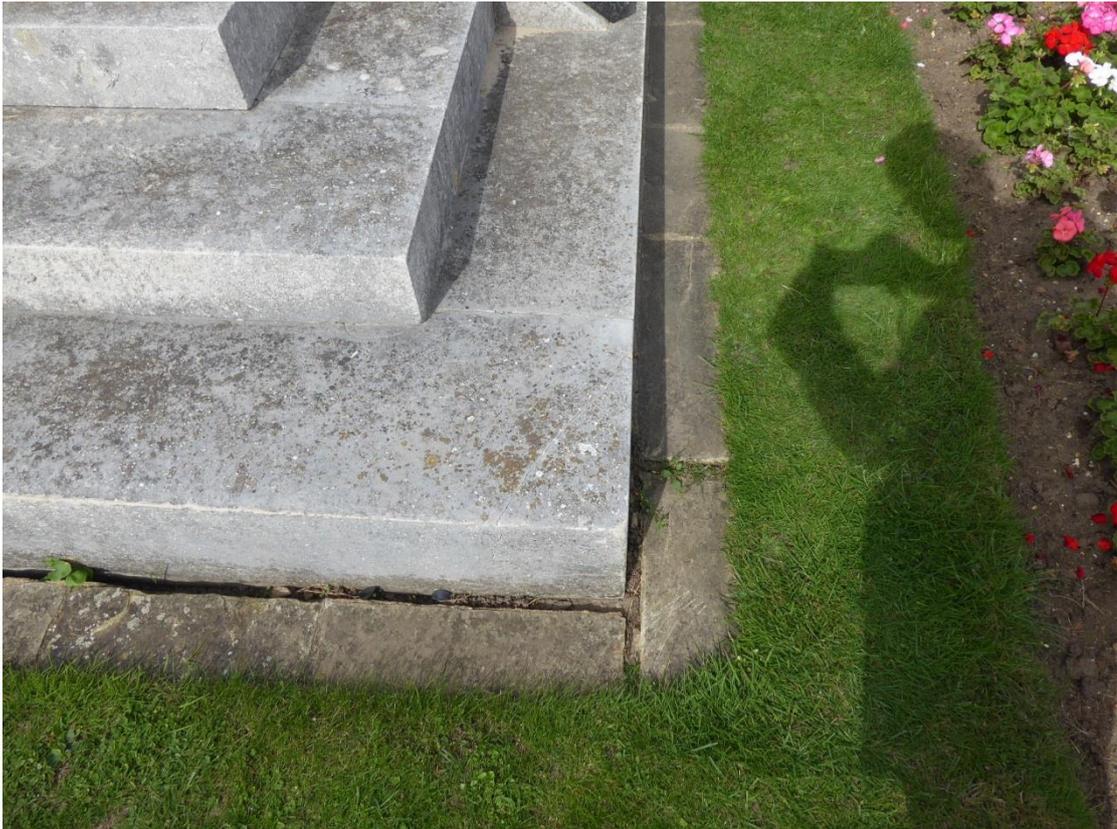
**21. Base, south east crack**

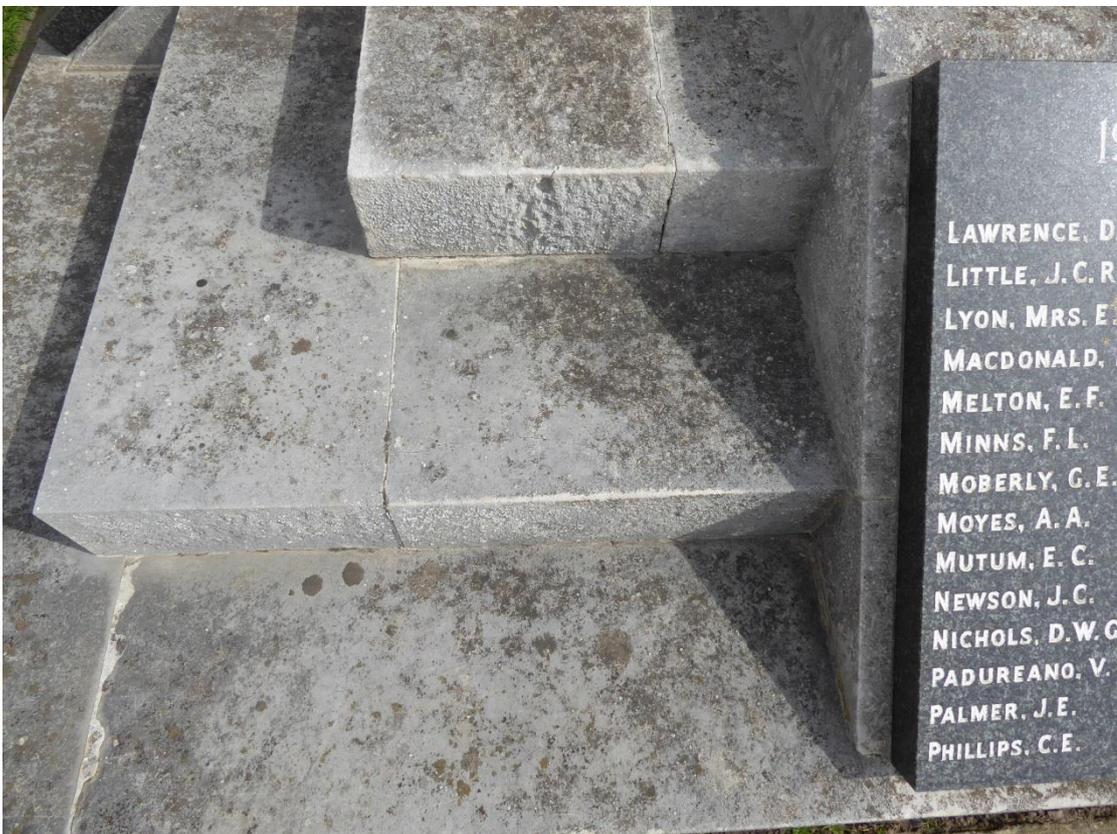
**22. Base, west crack**

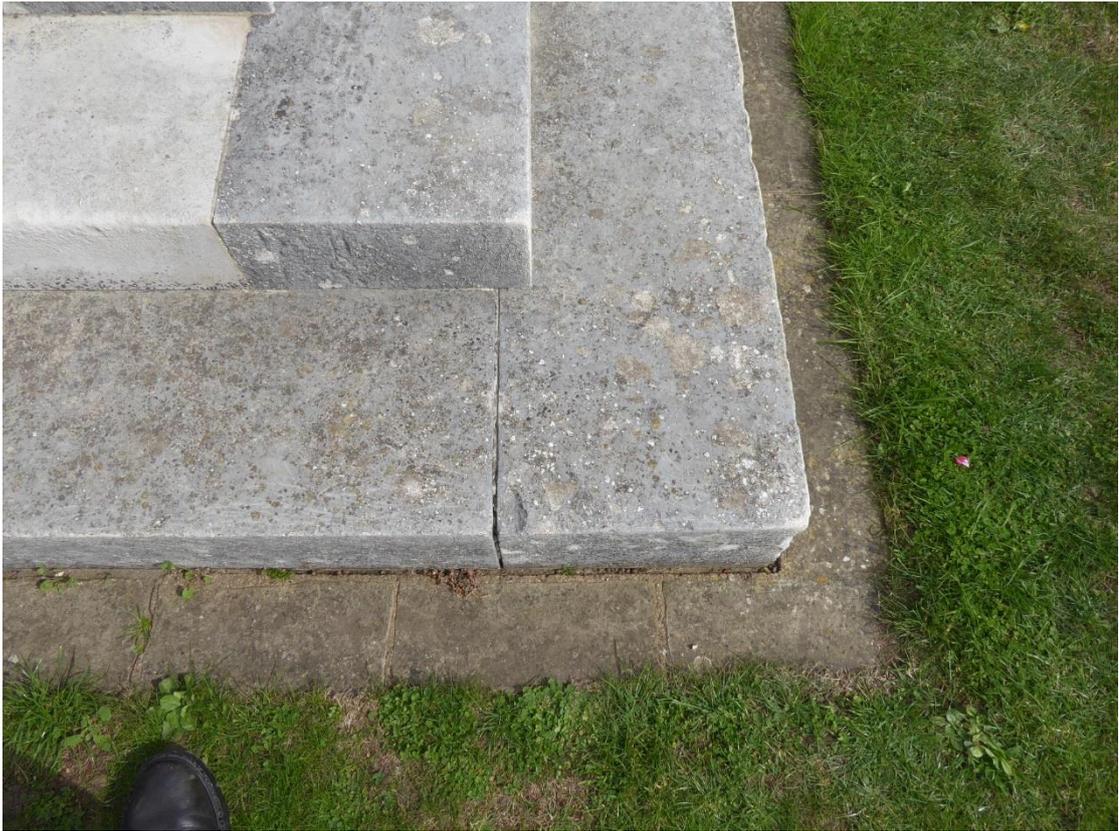
**23. Base, open joint**

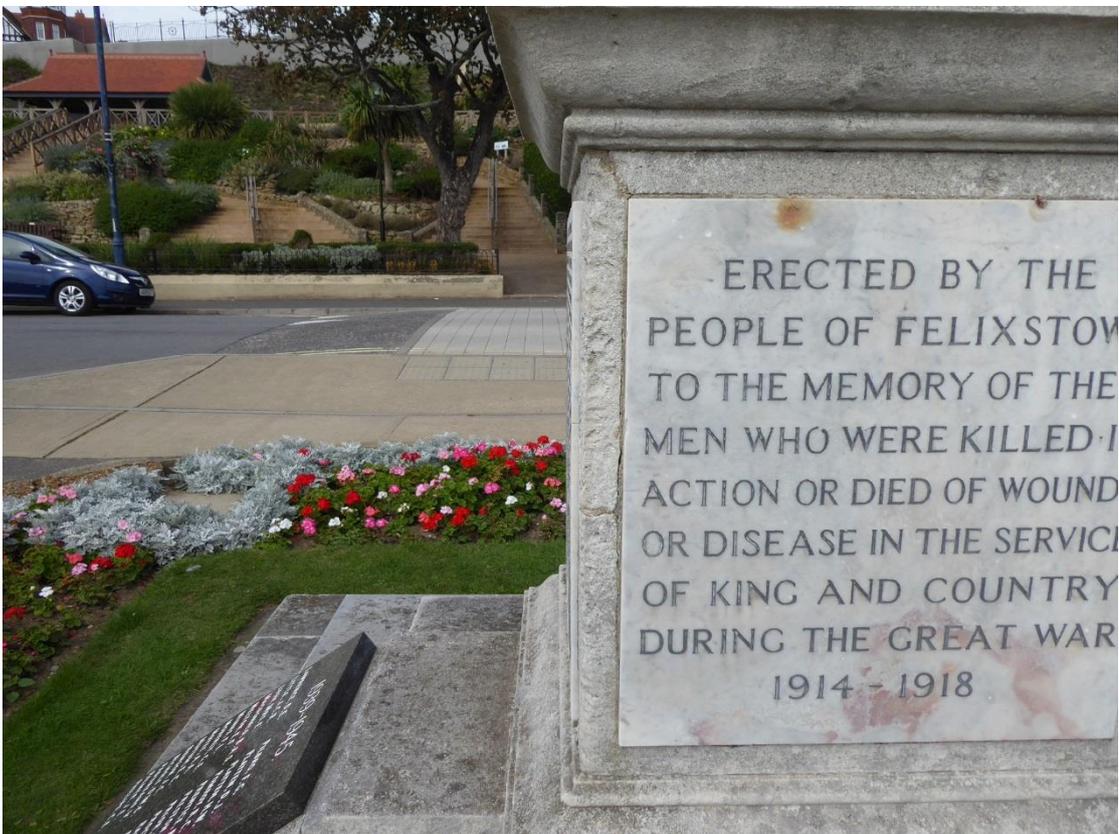
**24. WWI South tablet detail**

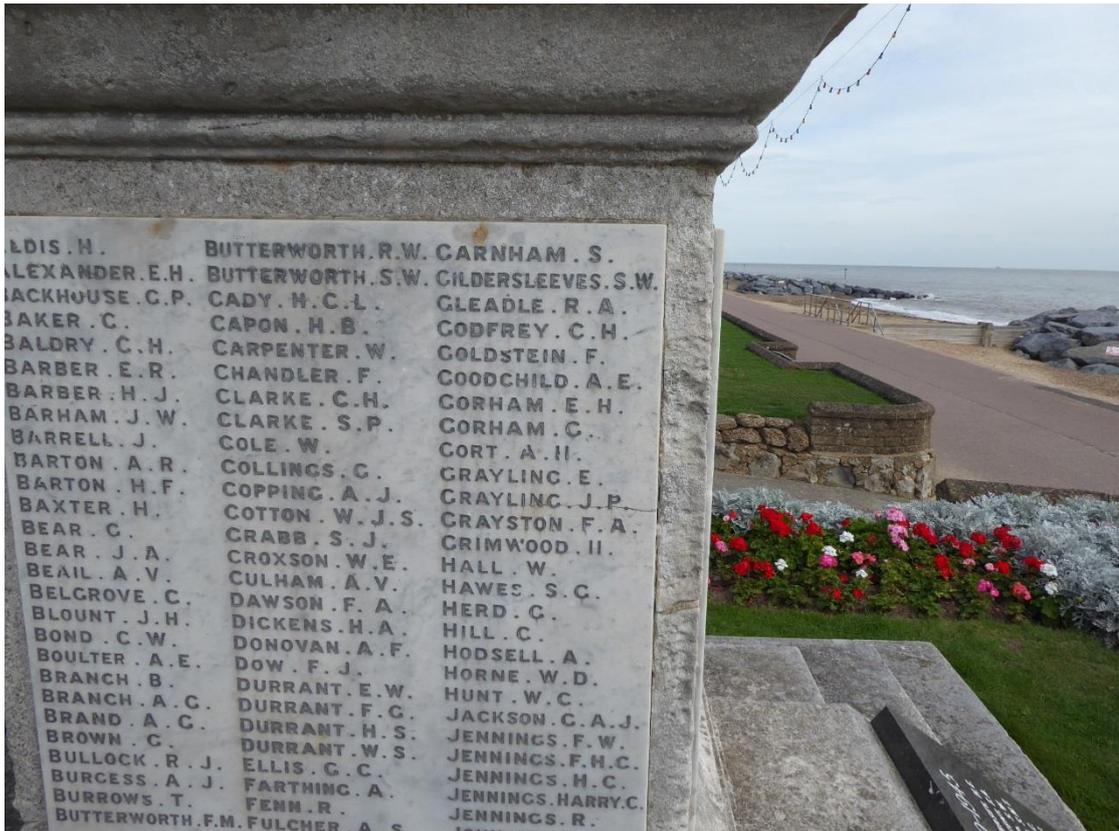
25. WWI West tablet detail.
